Colorado Forestry Best Management Practices

*Forest Stewardship Guidelines
for Water Quality Protection*

2016 Field Monitoring Report

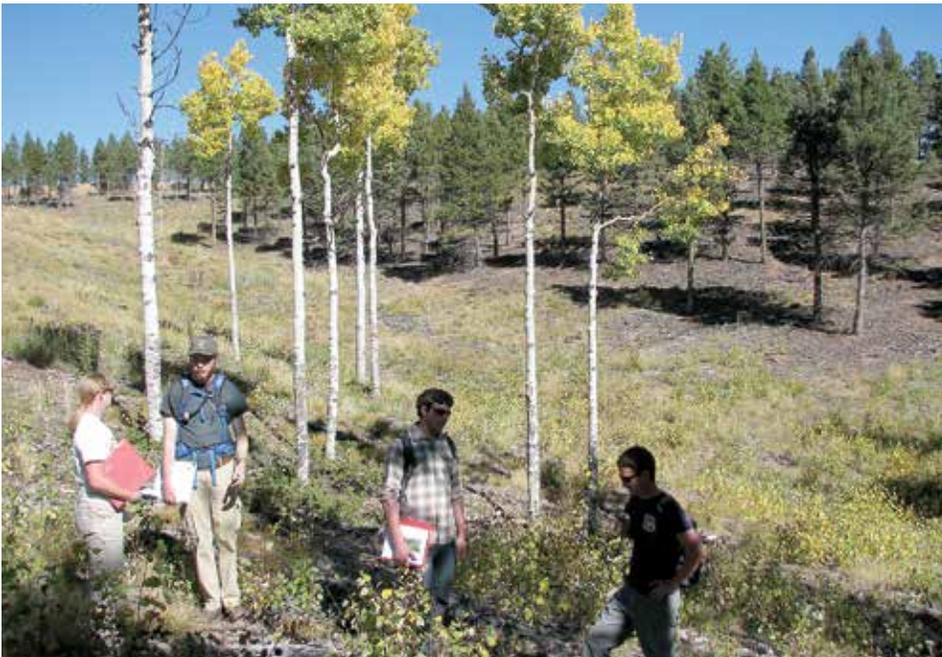
Figure 3: The monitoring team inspects skid trails and the Streamside Management Zone. Photo: R.M. Edwards, CSFS

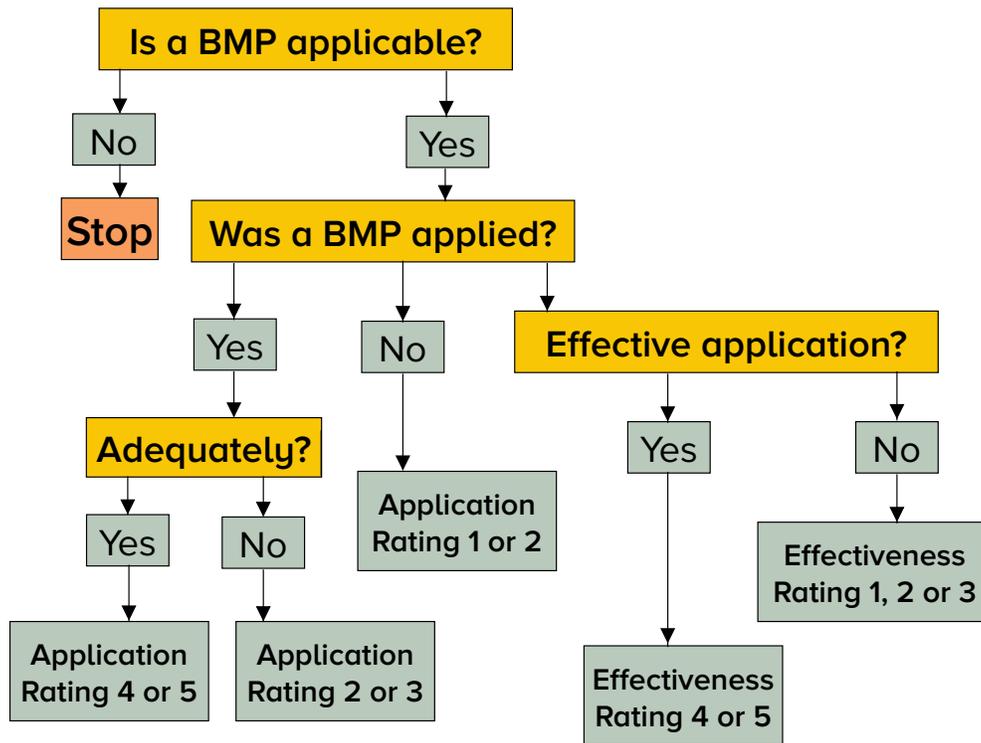
Figure 5: Colorado BMP Monitoring Ranking System

The rating process conducted for each BMP begins with establishing whether the BMP in question is applicable to the fuels management/harvest activities under consideration (Figure 5). For example, not all fuel treatment/harvest sites require the construction of temporary roads. In these cases, the BMPs that pertain to temporary roads are not applicable. Once the monitoring team establishes that a given BMP is applicable, the application rating for the BMP is determined, based on written criteria (Table 1).
