# Colorado Forestry Best Management Practices

Forest Stewardship Guidelines for Water Quality Protection

2021 Field Monitoring Report Compiled November 2021

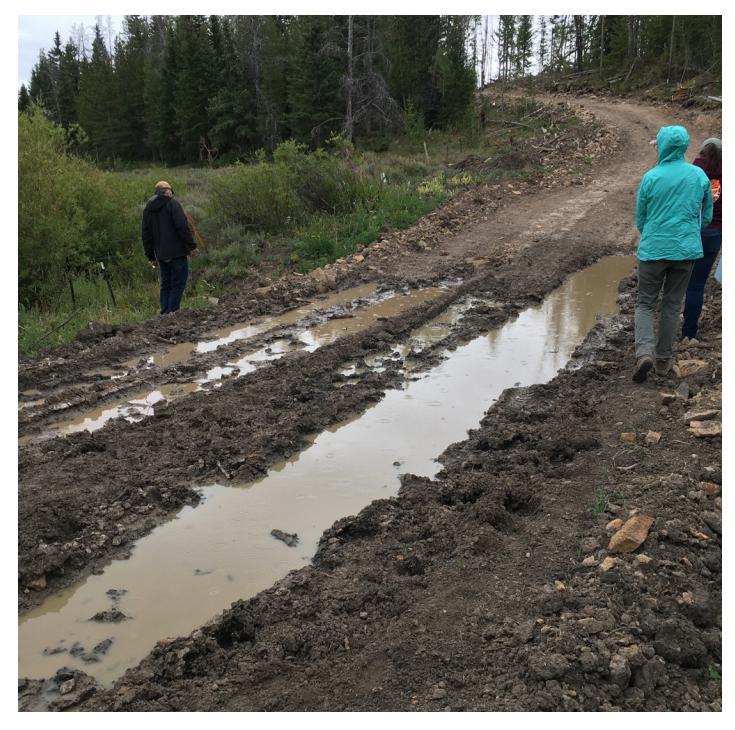
Figure 6: Team members observe inadequate drainage at a stream crossing. Photo: Diana Selby, CSFS

The fifth site, Sale #5, was found to have minor departures from BMPs including proper sizing for stream crossing structures and directing road drainage

away from a stream crossing site. In this instance, the monitoring team found that the two existing culverts that were installed for the crossing were inadequate and had begun to fill with soil. Additionally, drainage away from the stream crossing was not occurring. Even with these departures from application of BMPs, the team found that the soil and water resources were still adequately protected during the time of the evaluation. The team recommended that a larger and/ or longer culvert would have been more appropriate for the site.

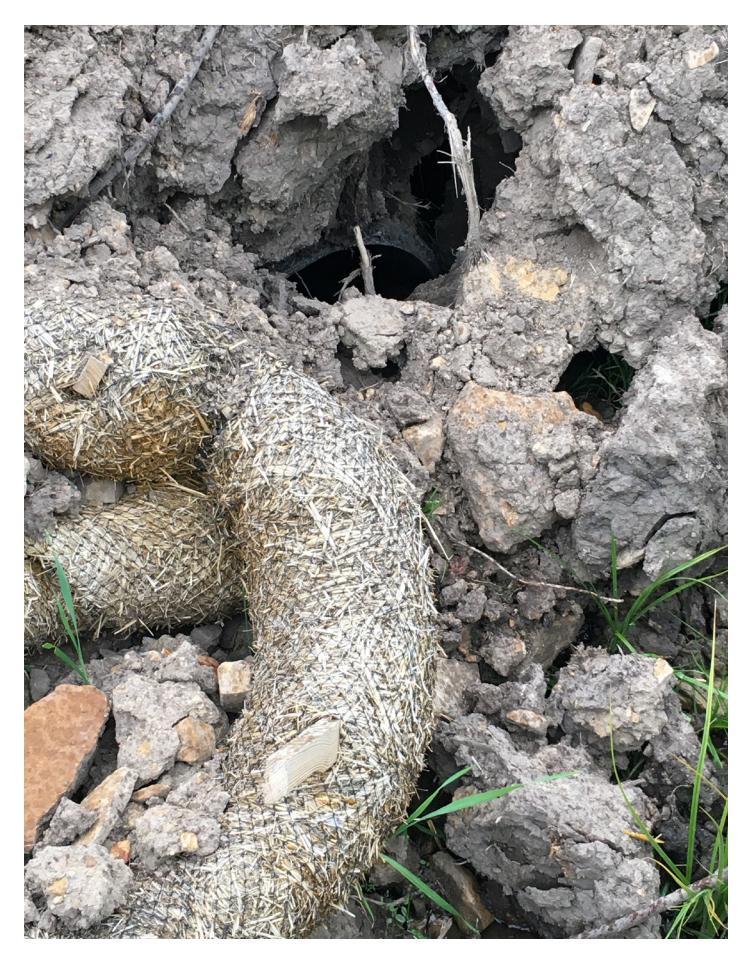
Figure 7: Materials fill in existing culverts on Sale #5. Photo: Diana Selby, CSFS

Sale #5 was found to have a minor departure in preventing erosion of the stream crossing culvert and the effectiveness was found to have minor and temporary impacts to the soil and water resources. Again, this rating was given because materials had begun to fill in the existing culverts.

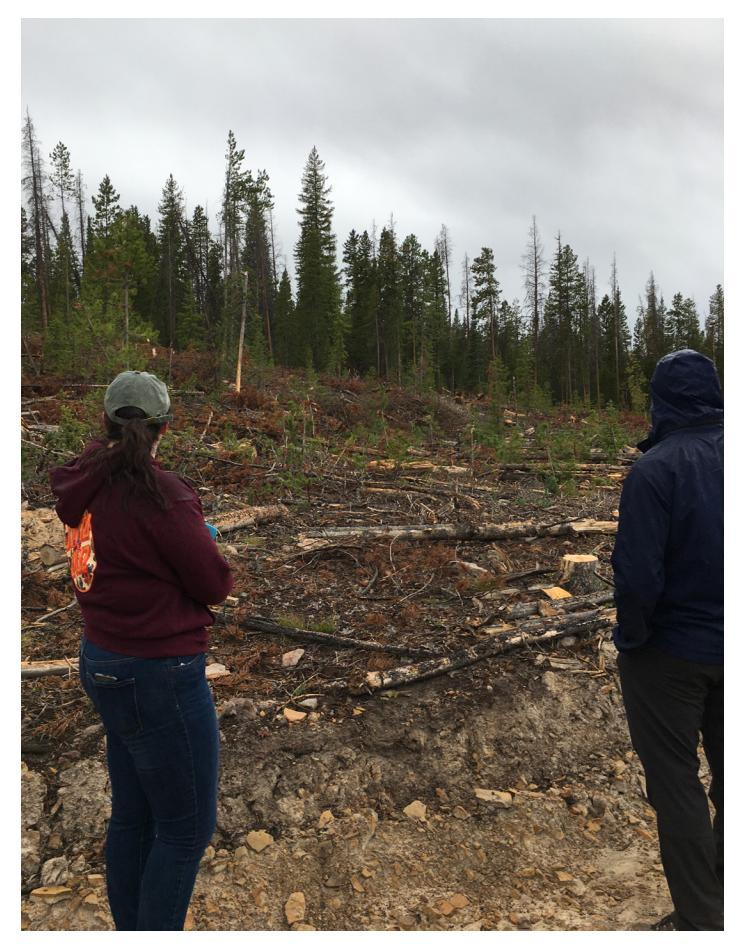
Figure 8: Team members view slash treatment that improved moisture and soil horizon on Sale #5. Photo: Diana Selby, CSFS

Scarification was used only on one of the sites (Sale #4) and met BMP requirements. All sites left adequate slash material to slow runoff, return soil nutrients and provide shade for seedlings. In addition, all sites limited activities to frozen or dry conditions to minimize soil compaction and displacement. Four of the five sites monitored treated their slash so as to preserve the surface soil horizon. The fifth site, Sale #5, was deemed to have improved the surface soil horizon
